Mechanical Engineer

Time duration December 28, 2017 to Jan 2, 2018

Location Saudi Arabia

Project High Vibration on Air Cooled GE 7A6 Generator

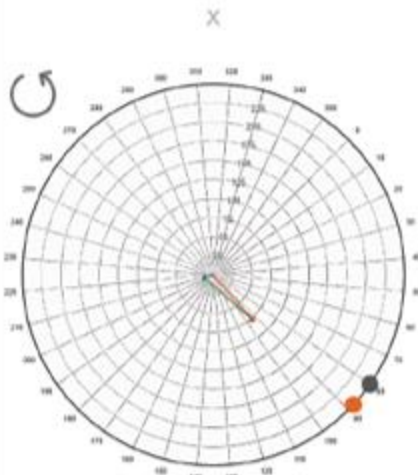
GEN COLLECTOR END

Sensor orientation 45 to Right
O vector → 78.5 @ 94
Calibration weight ● 750 gram @ 80
O+C vector → 12.49 @ 206
C vector → 83.98 @ 266.07
Correction weight ● 701.06 @ 87.93
Influence vector H 111.97 microns PP per KG @ 186.07

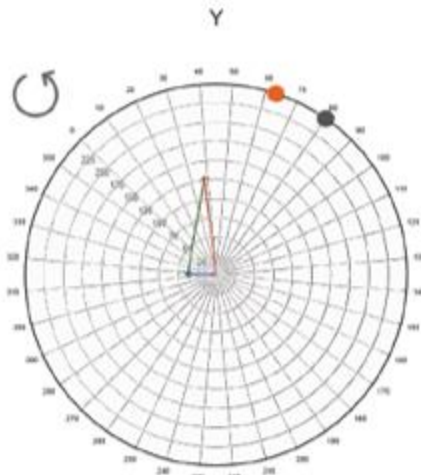
Sensor orientation 45 to Left
O vector → 128 @ 38
Calibration weight ● 750 gram @ 80
O+C vector → 37.37 @ 316
C vector → 128.25 @ 234.77
Correction weight ● 748.54 @ 63.23
Influence vector H 171.00 microns PP per KG @ 154.77
