## **Career Episode 3 on CDR Sample for Mechanical Engineer**

Project Restoration of GE 7FA-03 Gas Turbine after Compressor Wreck

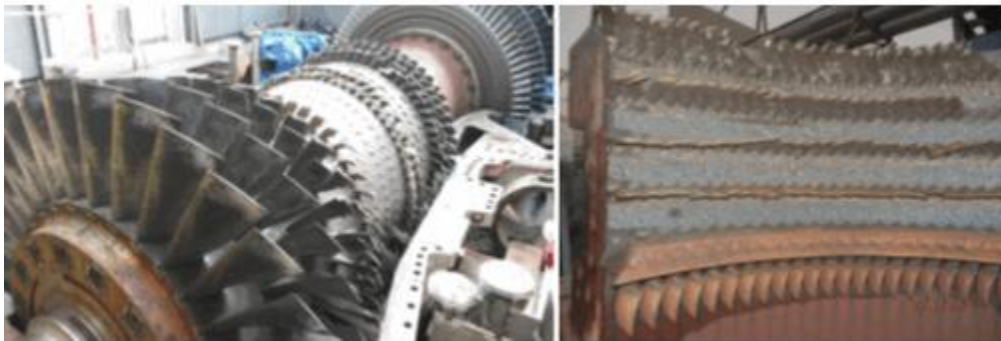
Damaged Assessment: After disassembly I started the project by conducting detailed inspection for making damage assessment of all the compressor rotor & stator vanes. The Mid Compressor Casing (MCC) was also damaged. Pictures of damaged rotor and stator vanes are given below.

On above grounds, I recommended to the customer that complete casing was also required to be replaced in addition to rotor and stator vanes.

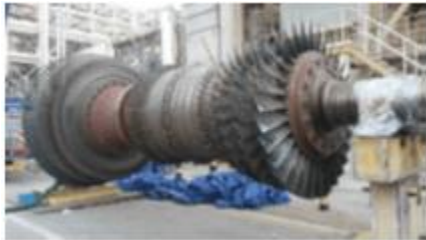
All the upper halves of casings (inlet, CDC, MCC, turbine & exhaust) were removed. After taking opening clearances, rotor was required to be rigged and removed. It was complex and important rigging having rotor weight of more than 50Ton; I designed a lifting plan keeping in consideration the center of gravity. Crane position, boom length, slings and lifting beam were key factors of lifting plan. The lifting plan was approved and rotor was safely removed and placed on rotor stands.

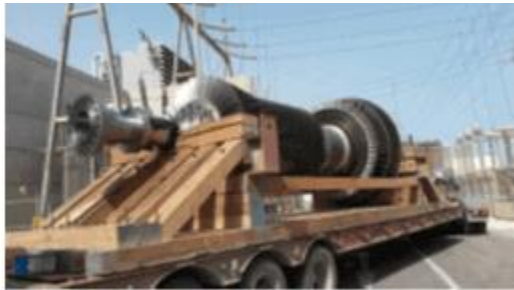
New rotor reaching at site

Compressor / Turbine Rotor was replaced with refurbished rotor on back buy deal with damaged rotor, the refurbishment was performed in GE Manufacturing facility Dammam Saudi Arabia (GEMTEC). The rotor had R0 blades with enhanced features of airfoil tuning, laser shock peening and dovetail undercuts.

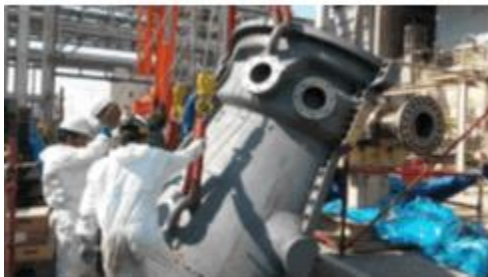
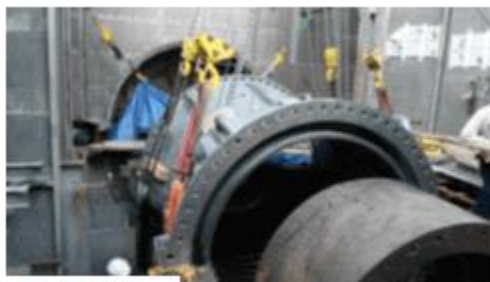
Installation of Mid Compressor Casing

As mentioned above Mid Compressor casing (MCC) suffered heavy dents and damages which were not repairable. MCC was replaced with new one. Prior to installing new MCC, bushings were installed on the dowel holes locations on inlet casing vertical joint (9 places). The purpose was to use the standard size dowel pins after casings alignment.

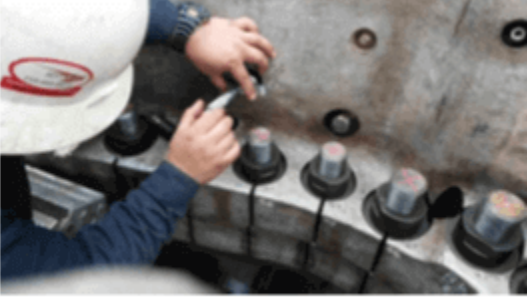
6 Point Check in progress

Turbine axial clearances measurement requires the rotor to be set at A-Set Dim with rotor pushed towards active side (exhaust end). While attempting to set the rotor at A-Set Dim by machining of active side thrust shim, it was found varying with temperature. The A-Set Dim was measured in the morning time and active thrust shim thickness was recalculated. Finally A-Set design dimension was achieved and clearances were measured. Compressor and turbine clearances were measured & recorded per new clearance drawing 104T9941 in FMI, all found within specs. Clearances were sent to design team for review and were approved. After installing all the upper half casings, the rotor 6-point check was

performed for rotor position and all clearances were found within specs. Inactive thrust shim was machined and Rotor thrust float was set at 10 mils.
